Urgent restoration in large-scale disaster

- Restoration of pavement in Chuetsu Earthquake -

Noritsugu Kusakari, Toshiyuki Kanai, Yukiei Masuyama

Seikitokyu-kogyo co., Ltd

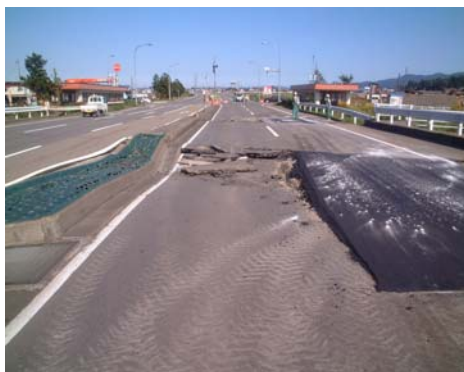
Before

A pair of photos below shows a section with a step-off and caving-in before and after the urgent construction work. The passing lane caved in by about 70cm and the part adjacent to a bridge sank by approximately 30cm. Tapering of the step-off in the urgent restoration work was executed with crushed stones and asphalt mixture (t=10cm).

Photo1. Step-off and caving-in before and after urgent construction work

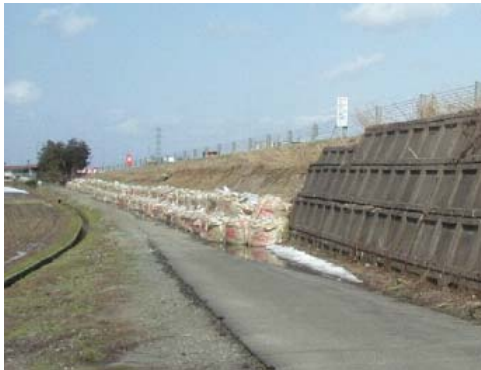
Urgent restoration

A pair of photos below shows a retaining wall rebuilt by the urgent restoring work and the full scale reconstruction work. The collapsed block was removed and the embankment was protected with sand bags in the restoration. The reconstruction made the wall, drainage system and frontage as they had been.

Photo3. Example of reconstruction
